United States  
Department of  
Agriculture

Forest  
Service

# Supplement to the Marys River Watershed Preliminary Analysis

**Siuslaw National Forest  
Fiscal Year 2005**

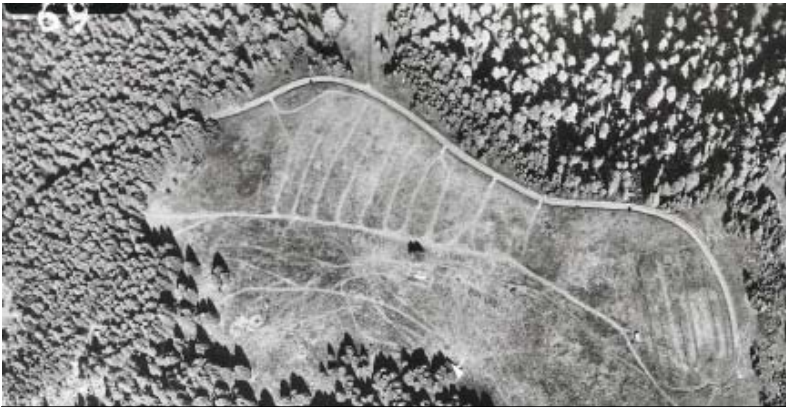
Figure 4: Sept. 1969 aerial photo showing impact of Trek activities on northern portion of large (east) meadow.

No information is available on potential recovery of the portion of the east meadow where the annual Shriner event took place in the Trek meadow. The annual Shriner event ended in the mid-1980's. Snow (1984) had speculated that grasses were more abundant than they would have been in that meadow because of human disturbance.

In more recent history, the northern most major meadow (Trek meadow) was the site of the Shriners' Annual Marys Peak Trek (1946 to the mid-1980's); as many as 10,000 people attended the yearly one day event. The Trek event turned the meadow into a parking lot with barbeque pit, approach ramps, access road, and stage. Some mowing of the meadow also occurred.
